# HYDROGRAPHIC DATA KEY ELEMENT IN *SS JACOB LUCKENBACH* OIL REMOVAL

By Joanna Hawkins

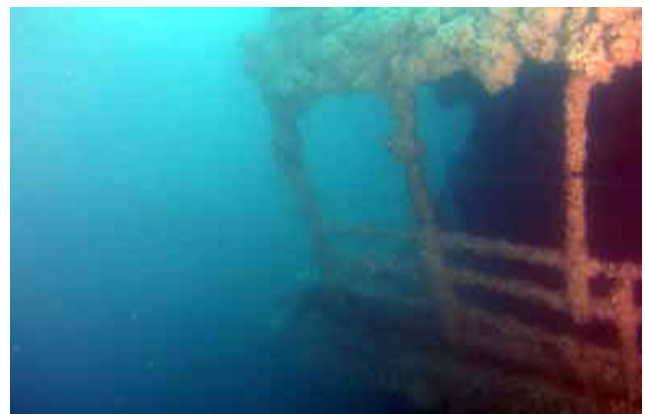
**Figure 4. Midship Photo from Submersible**

The USCG MSO also contracted with Deep Ocean Engineering Research (DOER) to visually investigate the wreck from a submersible. After several attempts that were hampered by strong currents and poor visibility, the crew was able to determine that the *SS Jacob Luckenbach* had broken into three pieces and that the wreck was heavily encrusted with nearly 50 years of marine growth (Figure 4).
